Healthy Buildings

January 29, 2018

Focused IAQ Inspection 5500 University Parkway, John M. Pfau Library

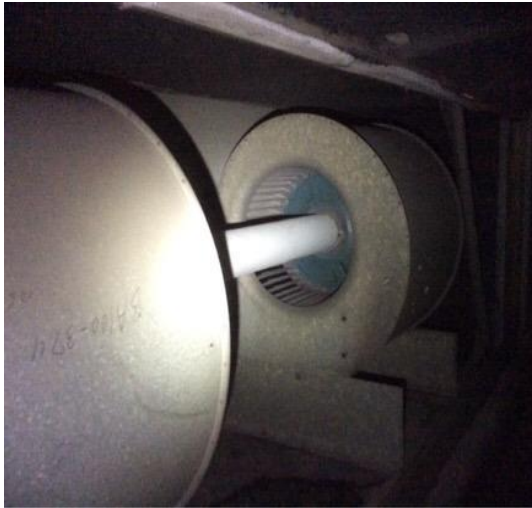
MZ 4 - A/S fans with trace dirt loading & rust on the inlet & housing

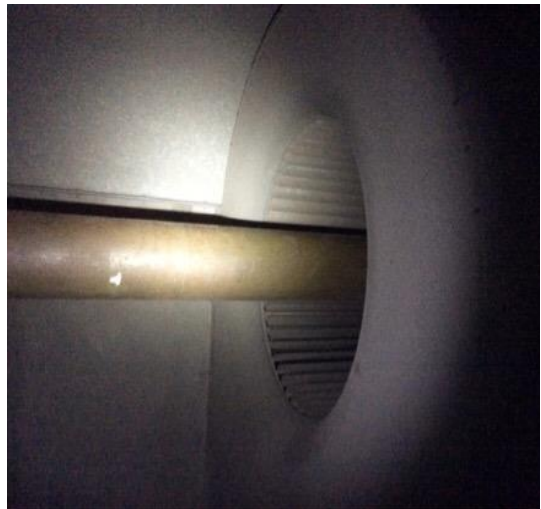
MZ 2 - A/S fan with trace dirt loading & rust on inlet & housing

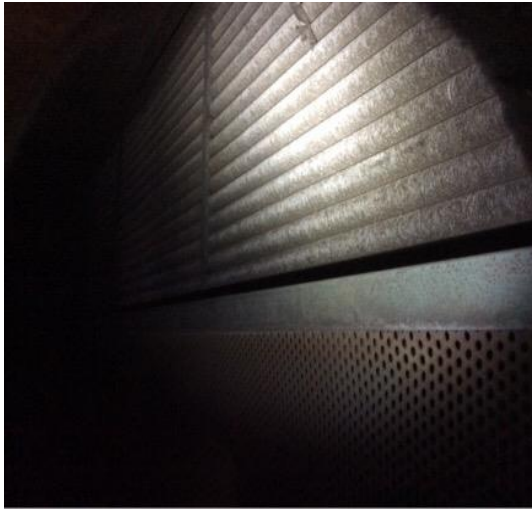
MZ 2 - heat coils with trace dirt loading & rust

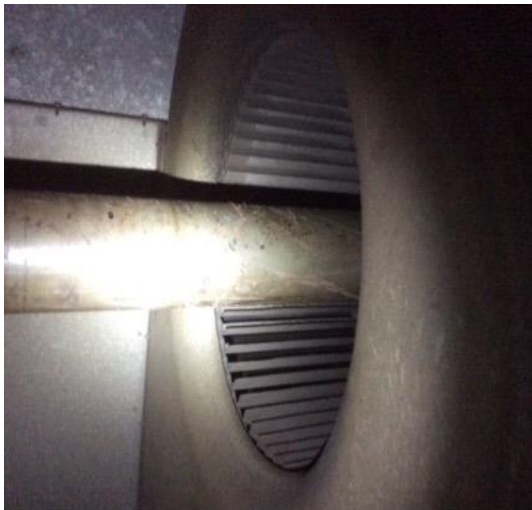
MZ 1 - A/S fan with trace dirt loading and rust on the inlet and housing.

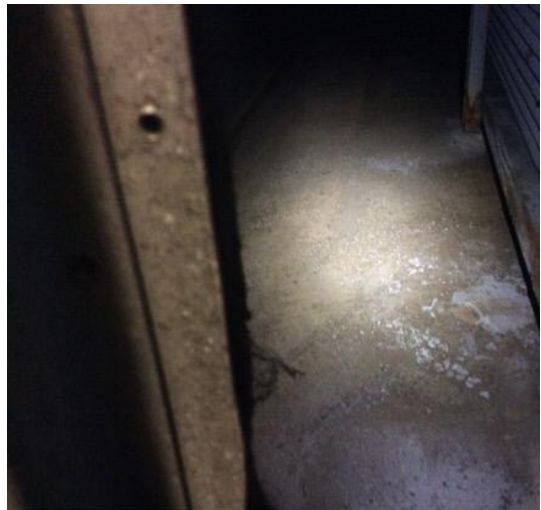
- The coils and condensate trays were in good condition in all units, except MZ 1, where moderate loading was noted in the condensate tray.
- Condensate drainage and traps were correct.

MZ 1 - condensate tray with moderate dirt loading and trace rust.

- In unit MZ 1, moderate loading was noted in the condensate tray. In order to prevent drain blockage and development of excessive bacteria and fungi we recommend cleaning the tray. The condensate tray should be treated with a rust protectant solution after cleaning. A suitable product is "Defender II", by The State Chemical Company, Cleveland, Ohio, 800-782-2436.

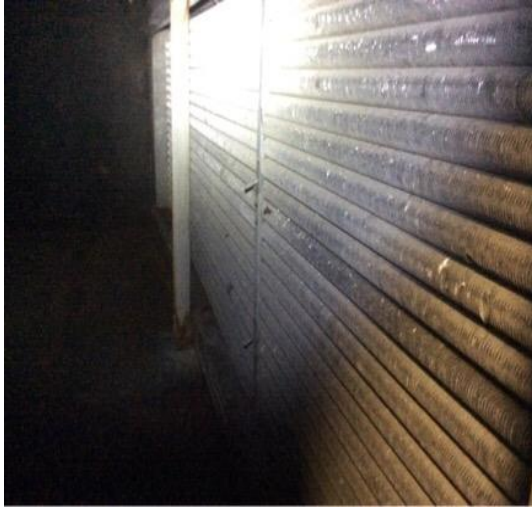
MZ 1 - coils with trace dirt loading and rust.

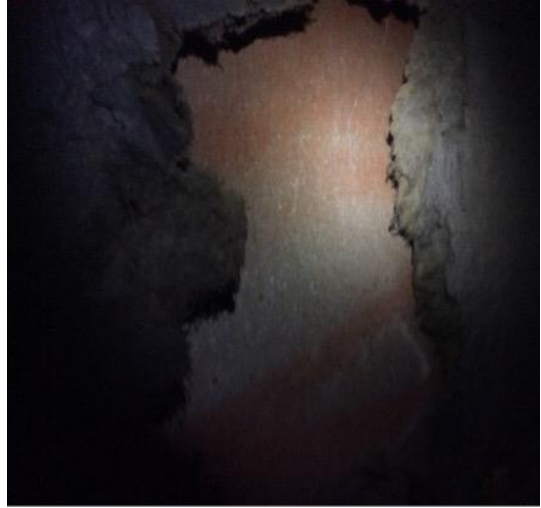
MZ 1 - torn insulation in the A/S chamber

- The fan chamber insulation in units MZ 1 and 3 wedge was noted to be slightly torn/frayed. This insulation should be repaired and sealed with an encapsulating preparation to prevent further deterioration and possible shedding of fibrous glass particles into the supply airstream. This damaged material can usually be effectively sealed with a spray or brush type encapsulant, such as Flex Seal™, manufactured by Controlled Release Technologies (www.novatech-usa.com/Products) or Fiberlock IAQ 7000 (www.fiberlock.com). We do suggest that rather than sealing patches of loose insulation, the whole surface of the exposed insulation should be sealed. This will retard further deterioration and significantly extend the life of the air handling unit. Should either of these encapsulants be used, it is important to let it dry completely before reattaching access doors or disturbing the applied surface in any way.

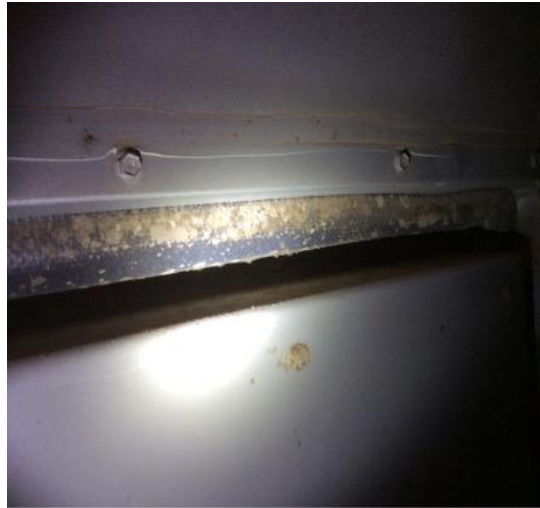
- The fan chambers were clean and in excellent condition for most units. In the 2 wedge unit, there was suspect microbial growth noted on the back side of the air supply fan and the vibration collar. Also, the fan chamber insulation in MZ 1 and 3 wedge was noted to be slightly torn/frayed. Lastly, for units 5, 6, MZ 2 and MZ 4, access to the units' various chambers was limited.

Wedge AHU 2 - suspect microbial growth on the vibration collar on the A/S fan

- In the 2 wedge unit, there was minor suspect microbial growth noted on the back side of the air supply fan and the vibration collar. These minor patches of suspect growth can be treated as a routine housekeeping function and remediated in-house. The procedure should be conducted outside normal office hours while wearing rubber gloves, eye goggles and an N95 (NIOSH Approved 95% efficient) respirator. The contaminated surface can be treated with a disinfectant solution that is approved for use inside HVAC systems, such as Fosters First Defense 40-80 (www.Fosterproducts.com), EnviroCon (Bio-Cide International, 2650 Venture Drive, OK 73069, 800.323.1398) or Sporidicin Disinfectant Solution (Sporidicin Products, 525 Locust Grove, Spartanburg, SC 29303, 1-800-762-3472). After thoroughly wetting the surfaces with the disinfectant, the suspect areas can be removed by scrubbing with any soap or detergent solution.

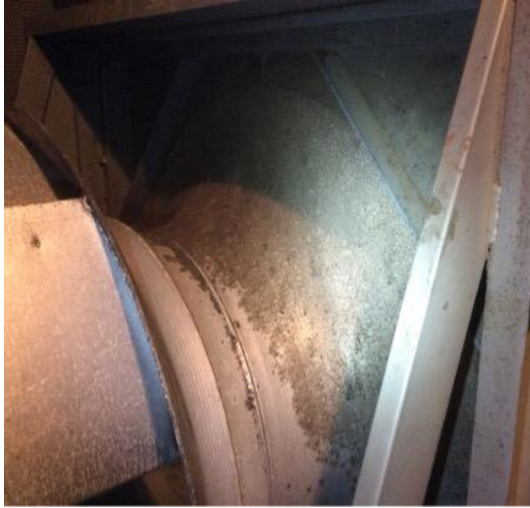
Wedge AHU 2 - suspect microbial growth on the back side on the A/S fan

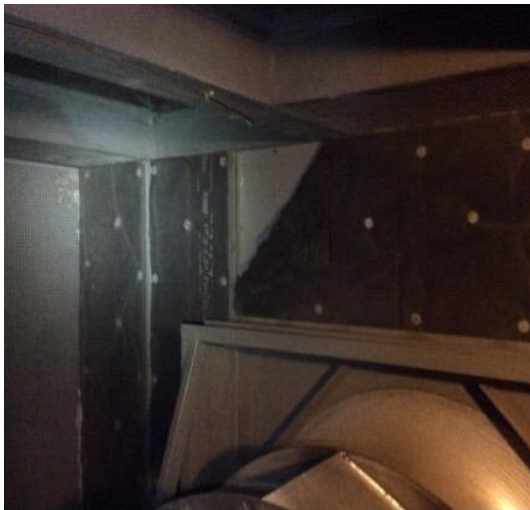
Wedge AHU 3 - torn insulation in fan chamber

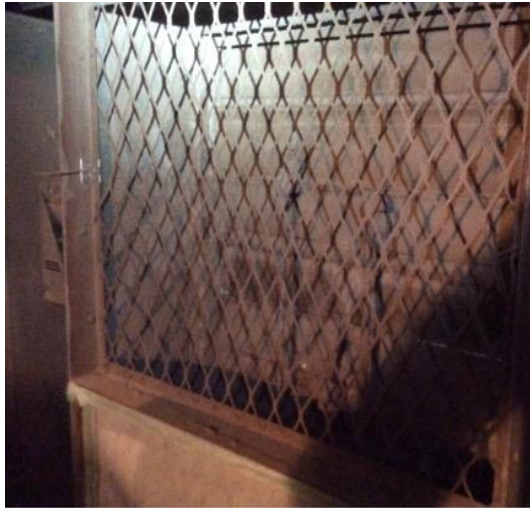
AHU 5 - O/A dampers closed

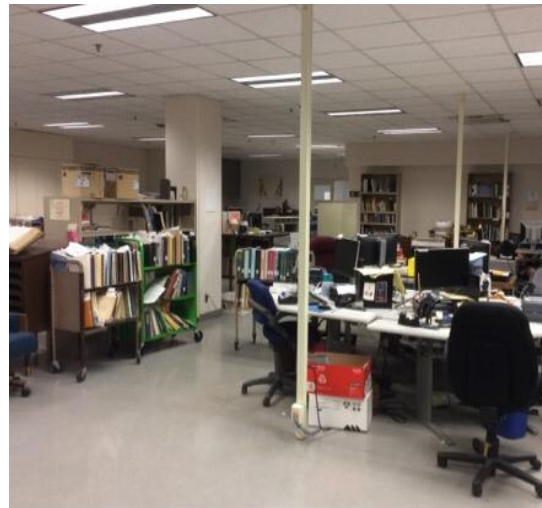
- In Basement Room 53 (Cataloguing and Tech Services) and Basement Room 49 (Library Receiving), a faint chemical-type odor was noted.
- In the perimeter Stairwell adjacent to Basement Room 49 (Library Receiving), noticeable chemical-type odors were noted.
- In Basement Room PL-014 (Photography), an air scrubber was noted in the area but not operating at the time of our inspection.
- In the Basement Open Student Space (by the south entrance), automatic doors were observed with heavy dust-generating construction activities noted directly outdoors.
- In the South Basement Entrance by Room PL-002 (Academic Technologies & Innovations), the entrance door could not close completely leaving a gap to the outdoors.
- In the Basement Hallway, a noticeable chemical-type odor was detected with the odor dissipating upon entrance to the nearby rooms.

Basement Room 49 Library Receiving Stairwell with single pane windows

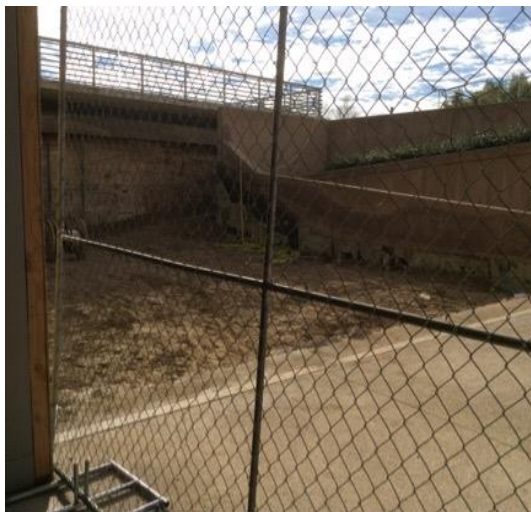
Basement South Side Entrance – reported issues with backhoe and dust control

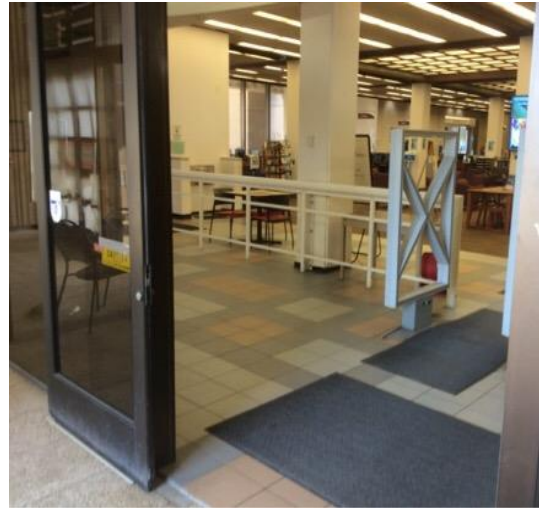
- In the 1st Floor Library Circulation Area, air scrubbers were noted and a very faint chemical-type odor was also detected.
- In the 1st Floor south entrance, two carpet fans were observed and automatic doors, in which the inner automatic doors were in an open position.

1F South Side with automatic doors open.

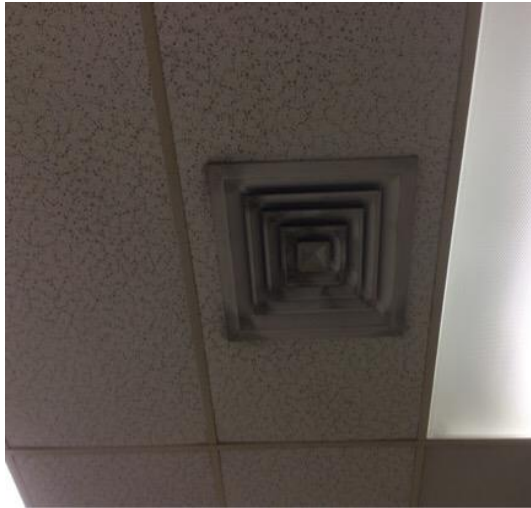
2F Classroom 214 air diffuser with trace/light dirt loading.

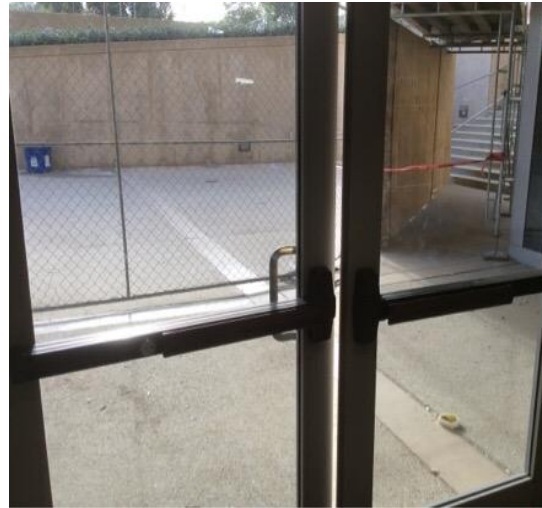
South Basement Entrance by Room PL-002 Academic Technologies & Innovations door could not close completely leaving gap

- In the South Basement Entrance by Room PL-002 (Academic Technologies & Innovations), the entrance door could not close completely leaving a gap to the outdoors. We recommend repairing the door to keep the area mostly sealed from outdoor construction activities.

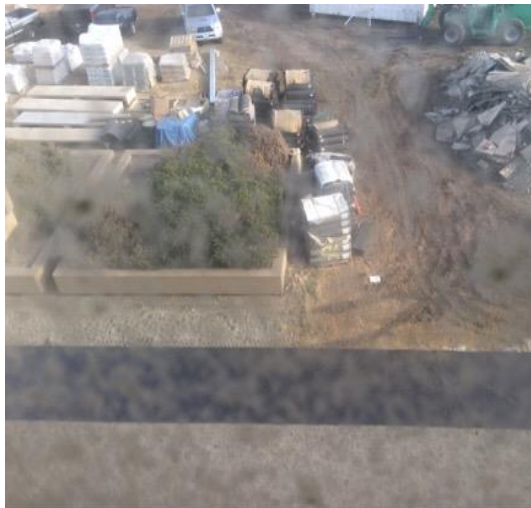
3F Room 301 outside office window - water proofing laid on ground.
