Pedestrian Safety at CSUSB PDC – Items of Concern

February 2018

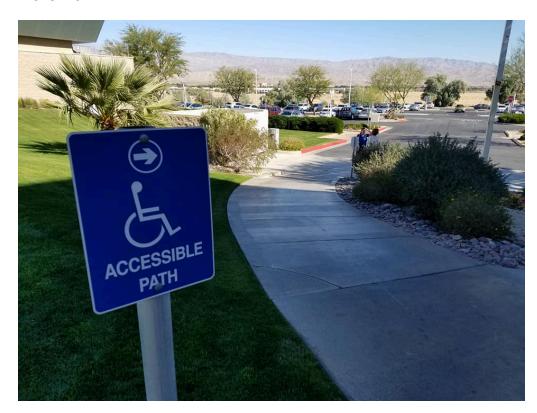
ITEM	SAFETY OBSERVATION	EH&S RECOMMENDED ACTION	RESPONSIBLE DEPARTMENT(S)
1	There is a short concrete ramp which leads from the east side of Indian Wells Theater to parking Lot A. This ramp is not ADA accessible because of the steep slope and lack of handrails. On the IWT end of the ramp, there is a sign that reads "(Wheelchair) Accessible Path →". This sign sits to the left of the ramp and points right, which is confusing to those who might misinterpret the path going straight ahead as being ADA compliant.	Install a "(Wheelchair) Not Accessible ↑" sign at the IWT entrance to the ramp, adjacent to the existing sign. The Not Accessible sign is present at the Lot A entrance. Install an "Accessible Path ←" sign at the Lot A entrance. (See pictures 1 and 2)	Facilities Planning, Design and Construction
2	Regarding the wheelchair-accessible ramp adjacent to Indian Wells Theater: there is a gap in the handrail where the ramp makes a 90- degree turn. The gap is big enough that someone in a wheelchair could veer off the ramp and fall.	Install a handrail to close the gap.	Facilities Planning, Design and Construction

Picture 1: Ramp at Indian Wells Theater entrance

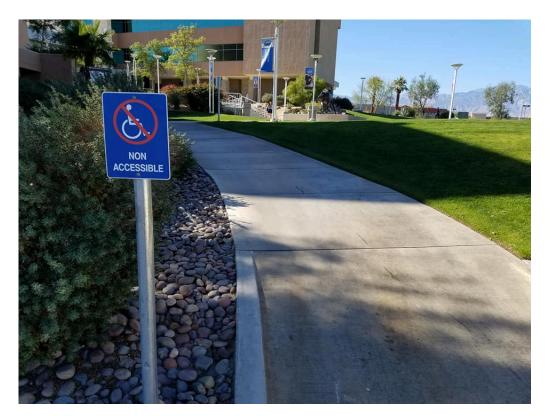
Picture 2: Ramp at Lot A entrance
