**WRPI Final Report 2019: Angeles National Forest, Stream Condition Inventory**

**Christopher Notto**  
**California State University, Northridge**  
**Kelsha Anderson, Forest Hydrologist**  
**Angeles National Forest**  
**8/29/2019**

# **Angeles National Forest Stream Condition Inventory, Eaton Wash, Eaton Canyon Reach**

**August 21, 2019**

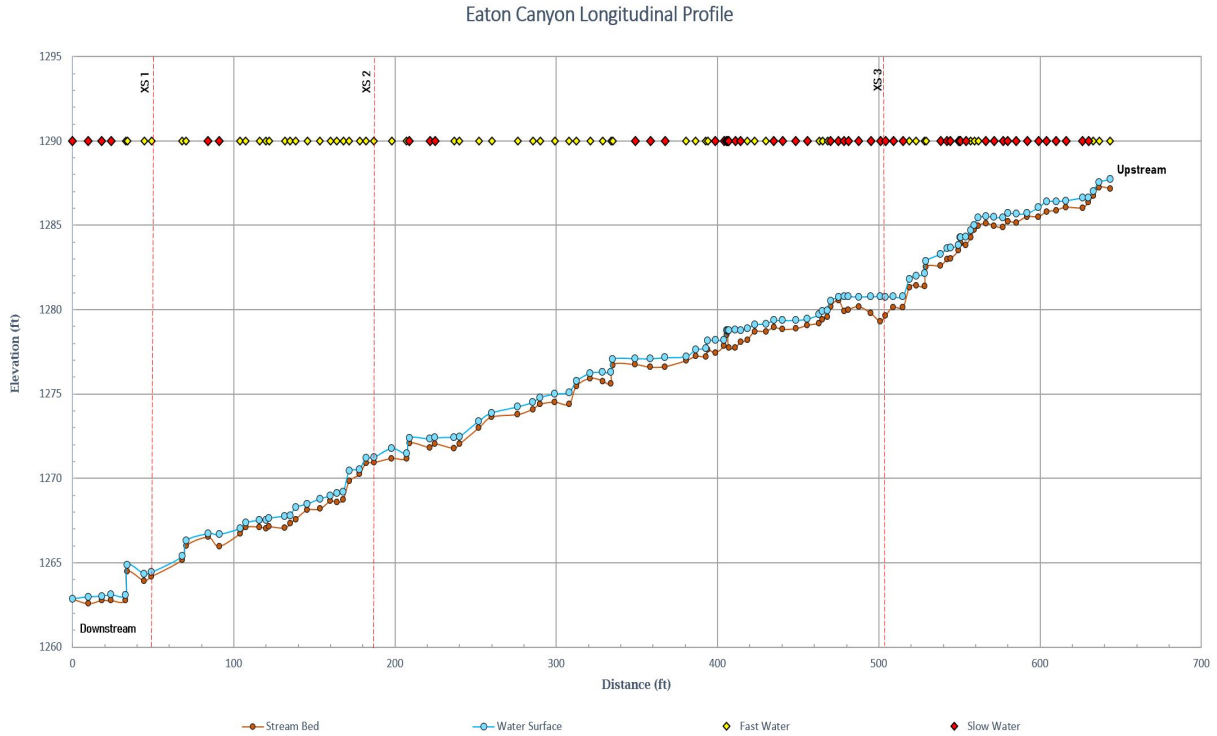
Figure 2: Longitudinal Profile of Eaton Wash, Eaton Canyon reach.

The longitudinal profile characterizes channel bed gradient, water surface gradient, and depths of riffles, pools, runs, glides, rapids and step pools (*Figure 2*). The average stream gradient is required for delineating stream types. At the broadest resolution level, fluvial geomorphologists recognize fast water (riffles, runs, and glides) and slow water (pools) as the two primary stream habitat unit types. These units are important attributes that explain the characteristics of its base stratification and topography of habitat that supports the life of aquatic organisms.

Stream Gradient for the Eaton Canyon reach was measured at 3.82%. The Eaton Canyon reach had 60% fast water features, while 40% was found to be slow water features (*Figure 2*). The series of sharp breaks along the longitudinal profile are step pool features (station 34 ft, 70.4 ft, 209 ft, 312.5 ft, 335 ft, 470.1 ft, 519 ft, 529 ft, 580 ft) (*Figure 3*). There is one elevation break occurrence that is caused by the presence of an unauthorized artificial dam that has formed a small pool feature.

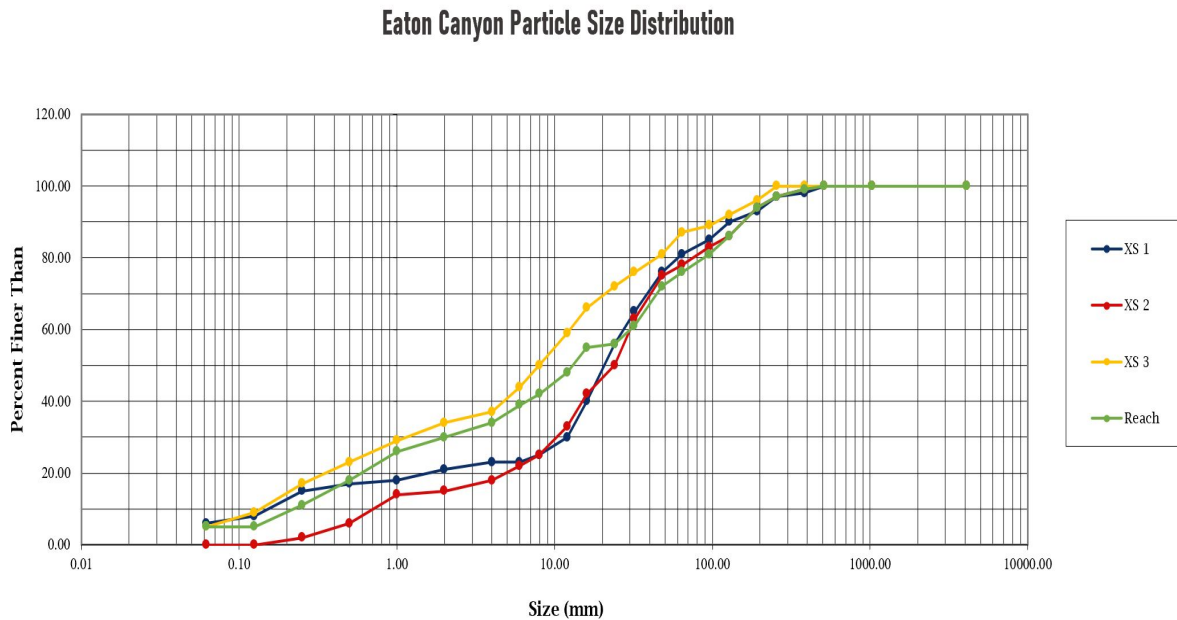
*Figure 6:* Particle size distribution analysis, Eaton Canyon.

Particle size distribution surveys were conducted at each of the three cross-sections and along the longitudinal profile to represent the studied reach (*Table 2*). *Figure 6* shows that particle size distribution is similar among the three cross sections. “Weighted particle size distribution” was collected according to the amount of fast versus slow water within the reach. In other words, 60% of particles were collected from “fast” water while 40% were collected from “slow” water.

D50 (diameter of the 50<sup>th</sup> percentile finer than) is the median particle size in the streambed used to classify stream type and can also provide a minimum estimate of the shear stress necessary to initiate general movement of mixed-size sediment (Rosgen, 2006; Elliot, 2002). D84 (84<sup>th</sup> percentile particle size) among the Weighted particle size distribution is used in part to estimate Manning’s roughness coefficient. Manning’s roughness coefficient is then used in part to estimate bankfull velocity and discharge. Percentiles for all three cross-section pebble counts and the weighted reach pebble count can be found in *Table 2*.
