Upper Big Creek Priority Watershed Road Inventory and Hydrologic Conductivity Assessment

Blue Canyon, Sierra National Forest

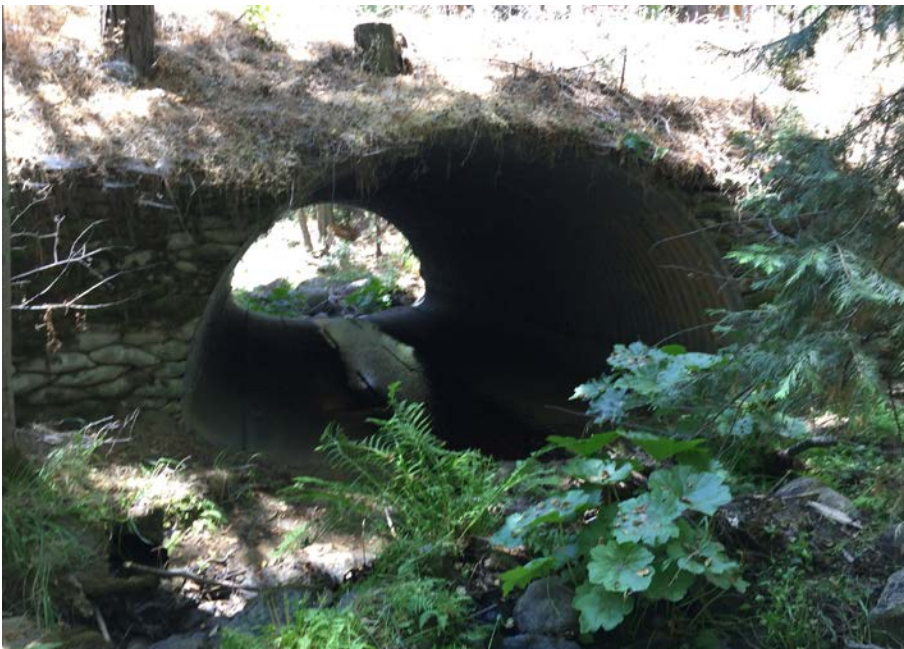
Figure 2: 100inch culvert near Bretts Mill WorkStation.

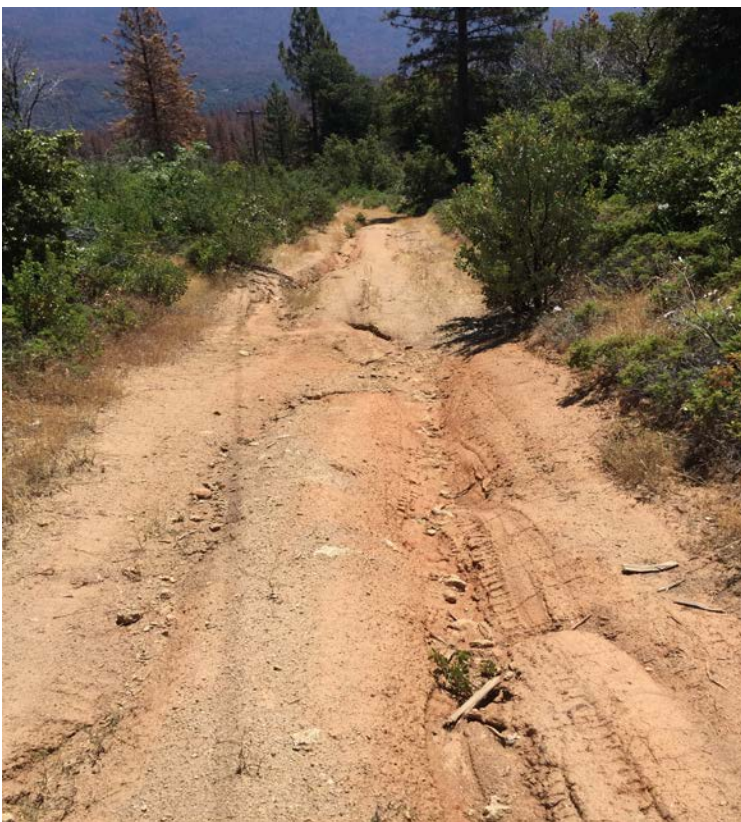
Figure 3: Segment of Road 10S090, showing signs of surface erosion

As a final statement to the Upper Big Creek Priority Watershed Road Inventory and Hydrologic Assessment, my partner and I believe that the Upper Big Creek Watershed is prone to excess sedimentation into the stream channels as a

result of the current road designs in the Blue Canyon area (see figure 3). We strongly believe that efforts to redesign the roads in this watershed will help to decrease erosion of roads and help prevent further surface road erosion into our stream channels and Pine Flat Reservoir.

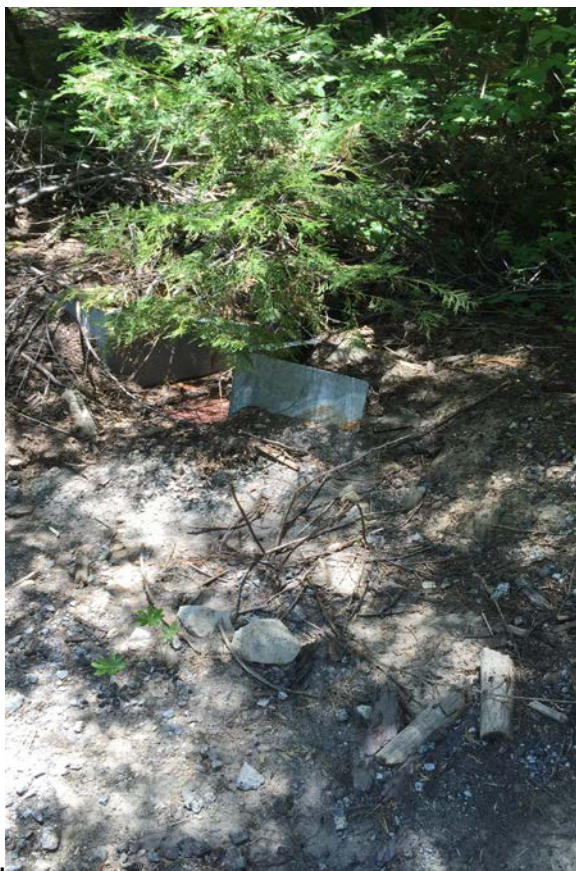
Figure 4: Overside Drain filled with debris.

current road systems, water bars, and other road drainage efforts throughout the watershed which allow water to pass under the roads and directly into stream channels (see figure 4). Reducing sediment discharge into these stream systems has been identified in the action plan for the Big Creek Watershed, a tributary to the Kings River which drains into Pine Flat Reservoir.

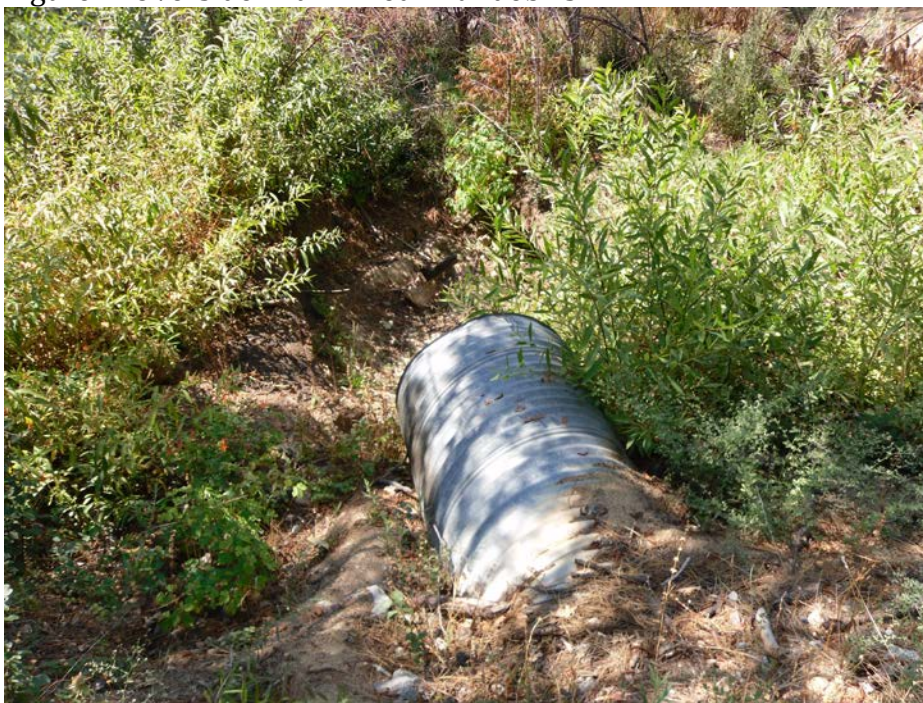
Figure 5: Shotgunned culvert off roadside with and outlet drop.
