# Trail Management & Watershed Condition Improvement

## Caldwell Lakes Trail Reconstruction and Realignment

June 16 – August 15 2017

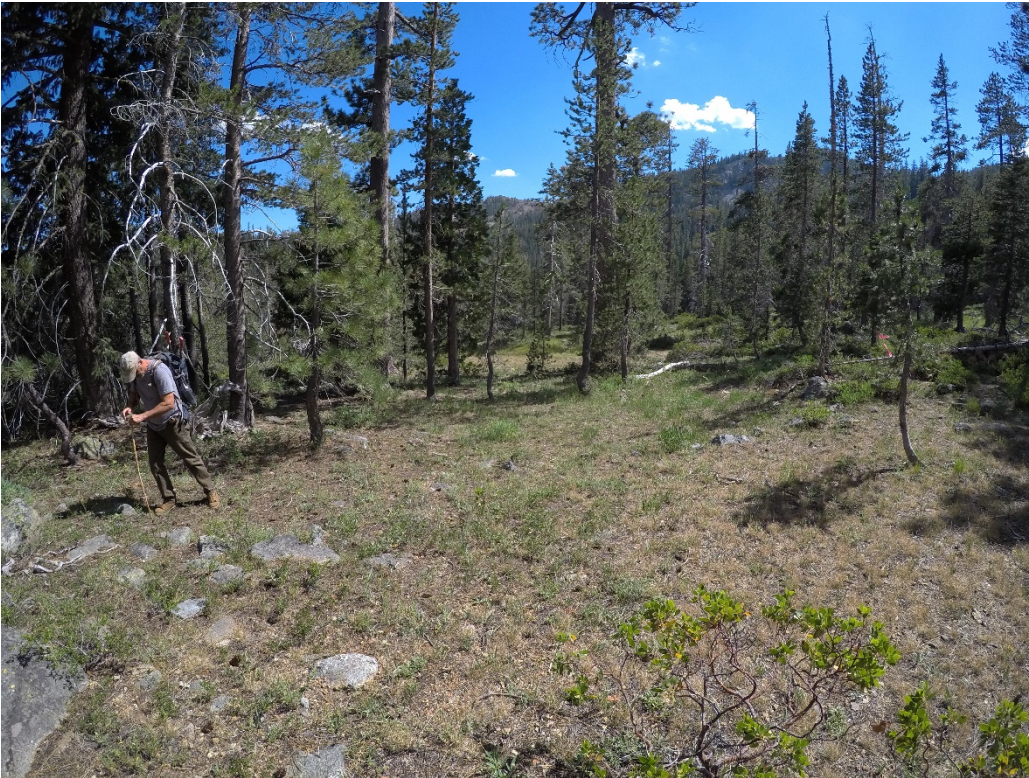
*Figure 4*

out slope. The rock trail made also makes it difficult to maintain tread in the area due to a cusp that has been made from water running down the trail. A few things I noticed that were working really well in terms of watershed, were rock dams and causeways that were built along the trail (Figure 4 & 5). These rock causeways and dams seemed to work well in an area that has a lot of snowfall and water. This project built on the skills I already know and took them to a more technical level that involves stewardship and management.
