# HYDROLOGIC CONDUCTIVITY ASSESSMENT IN THE UPPER BIG CREEK WATERSHED

A final report submitted to Water Resources Institute/ UEC at  
California State University, San Bernardino

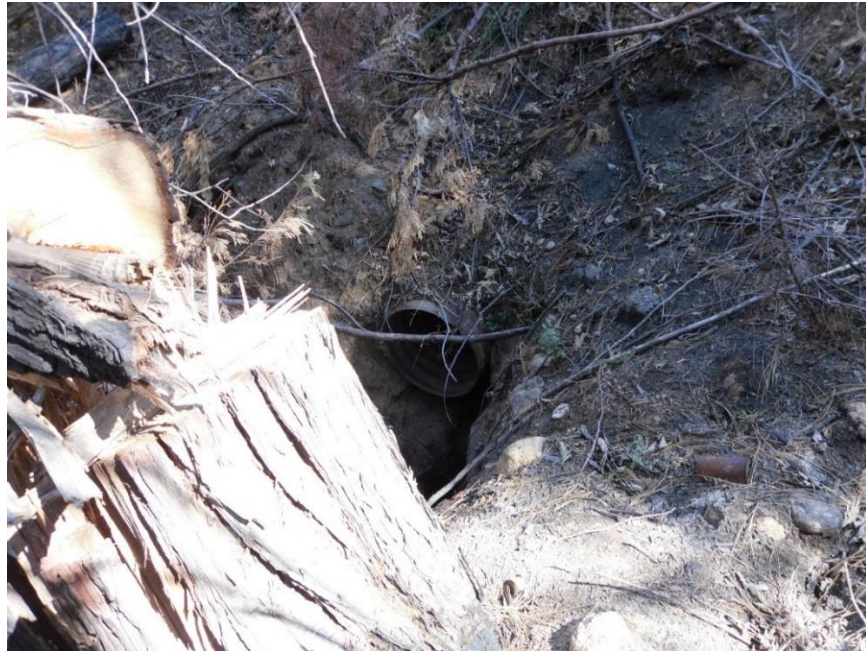
Figure 2: Culvert outlet, sometimes hidden or buried under fallen trees, debris or vegetation.

Most of these stream crossings were facilitated by culvert systems (see figure 2 & 3) that measured from 18 to 100 inches in diameter and range from 30 to 50 feet in length. Key inspection criteria were: fine sediment alongside the road, erosive activity such as rill or rut development, debris buildup in culverts, overside drains or inboard ditches, damage to

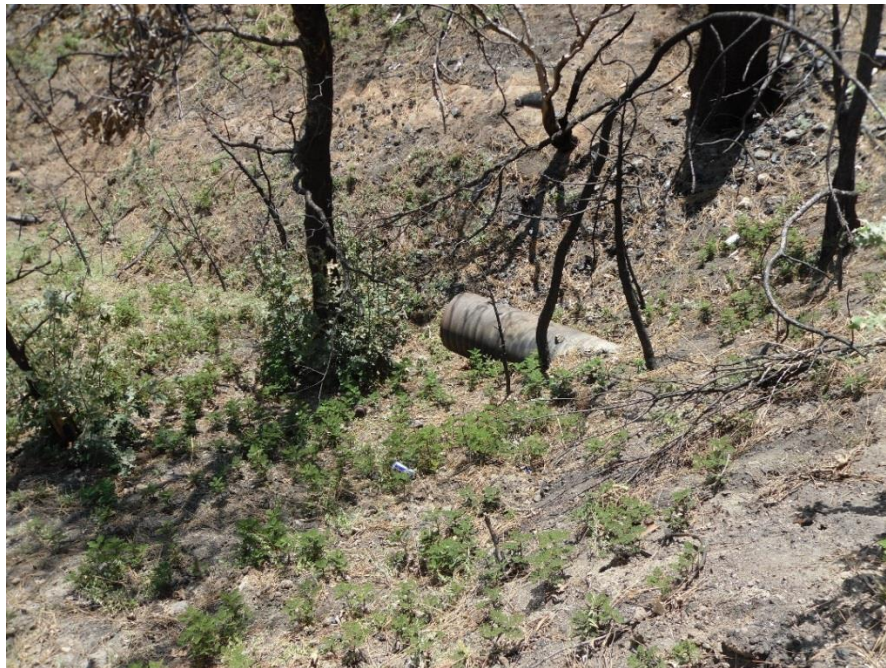
Figure 3: Culvert outlet with a shot gun. Protocol for culverts included measuring the culvert length, diameter, and outlet drop.

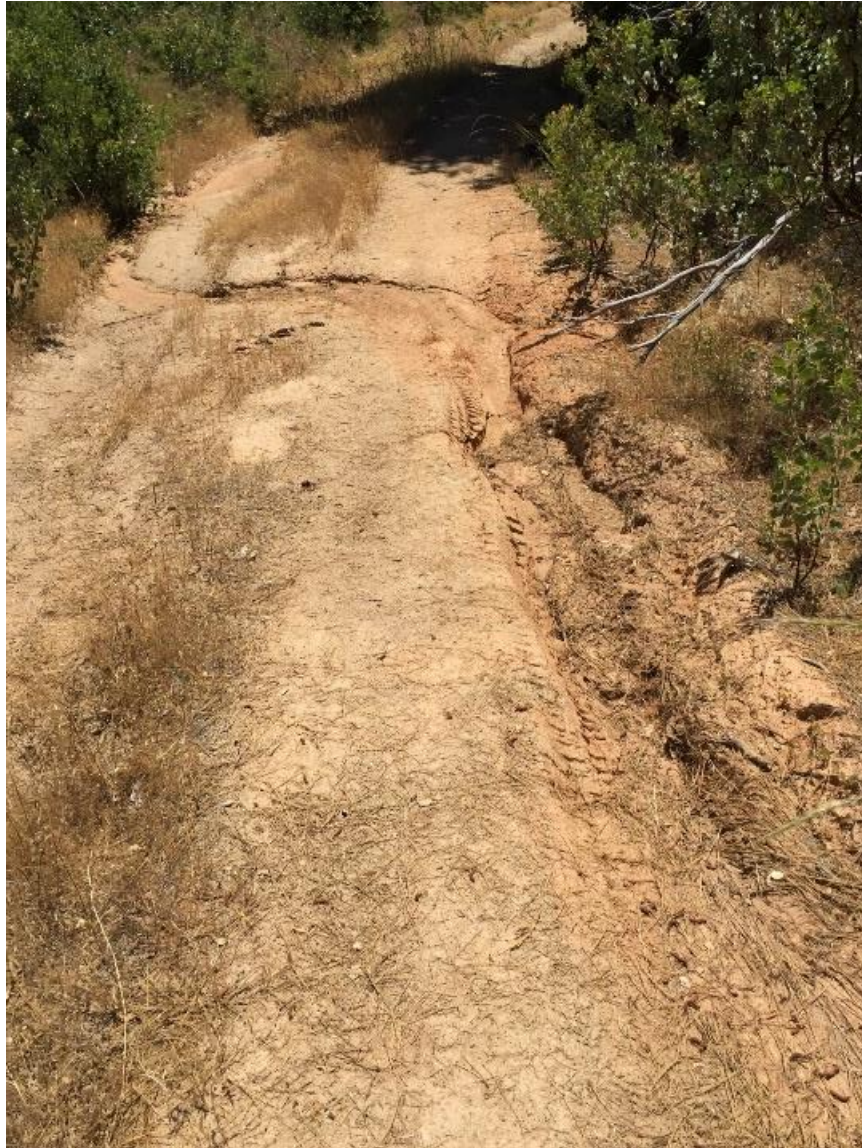
Figure 4: Road 10S090 is a good example of a hydrologically connected road segment with a failed waterbar and rills developing on the right side of the photograph.

Conducting the hydrological assessment is only half of the work for this project. Developing a maintenance plan that will ensure that damaged and plugged culverts get fixed, as well as redesigning roads that are insloped, may substantially reduce hydro-connectivity and lessen sediment discharge into Big Creek and Pine Flat Reservoir. Although the internship is coming to a close, it's a great feeling knowing that partner and I took part in the restoration of the Upper Big Creek Watershed. Working as a geologic technician this summer has reinforced our goals to work towards becoming a hydrologist or geologist. The
