# Assessing physical, chemical and biological parameters of stream communities along watersheds of the Los Padres National Forest

California State University Monterey Bay

Water Resources Institute, California State University San Bernardino Watershed Management  
Experimental Learning for USDA Careers

Project Date: June 2016 – August 2016

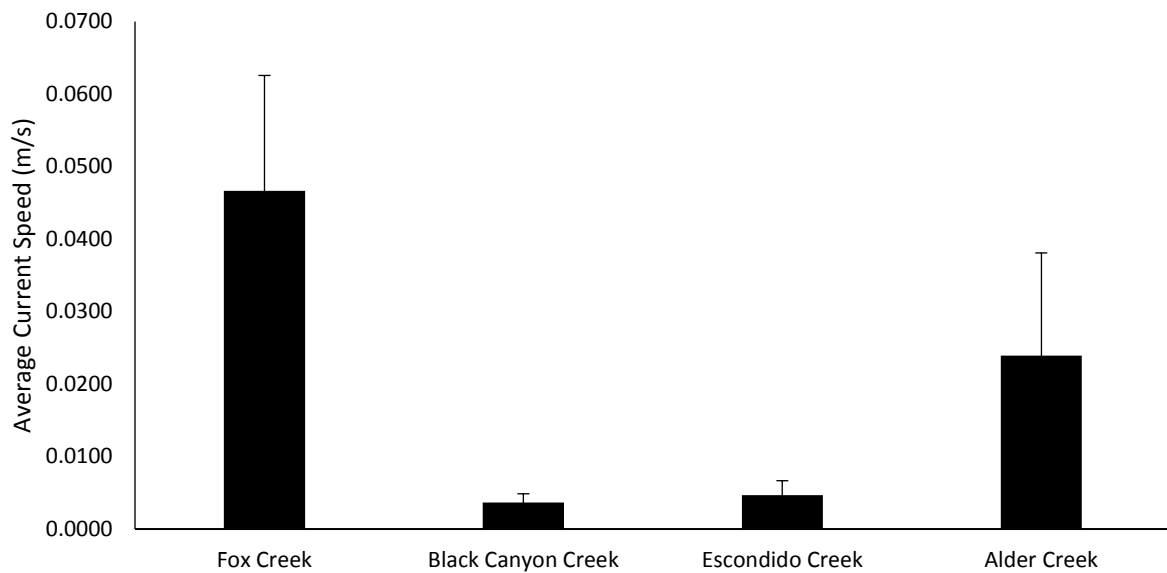
**Figure 2.** Average stream depth, current speed, canopy cover and wetted width for Fox, Black Canyon, Escondido and Alder Creeks on the LPNF.

After the data were collected, we transferred the data to Excel and created figures describing the results. When more than one data point was collected, a mean and standard error for each variable within the reach was determined and graphed into figures (Appendix A). Substrate size class determinations were performed using the Wentworth grain size scale, which provides a phi value ( $\Phi$ ) for any given substrate (Wentworth 1922). Figures for Wentworth Scale averages for substrates within each stream reach were also plotted (Appendix B).

Black Canyon, a tributary to Santa Cruz Creek, was a fairly stagnant creek with overgrown cattail (*Typha* sp.) along majority of the reach (Appendix C). This was the only creek that was sampled and was heavily impacted by the Zaca Fire as evident by the reduced canopy cover (Appendix A). Average substrate size at Black Canyon was smaller than the rest of surveyed creeks and could be the result of the wildfire that burned through. The finer sediments do not provide suitable rearing habitat for rainbow trout (*O. mykiss*) and thus the likelihood of their

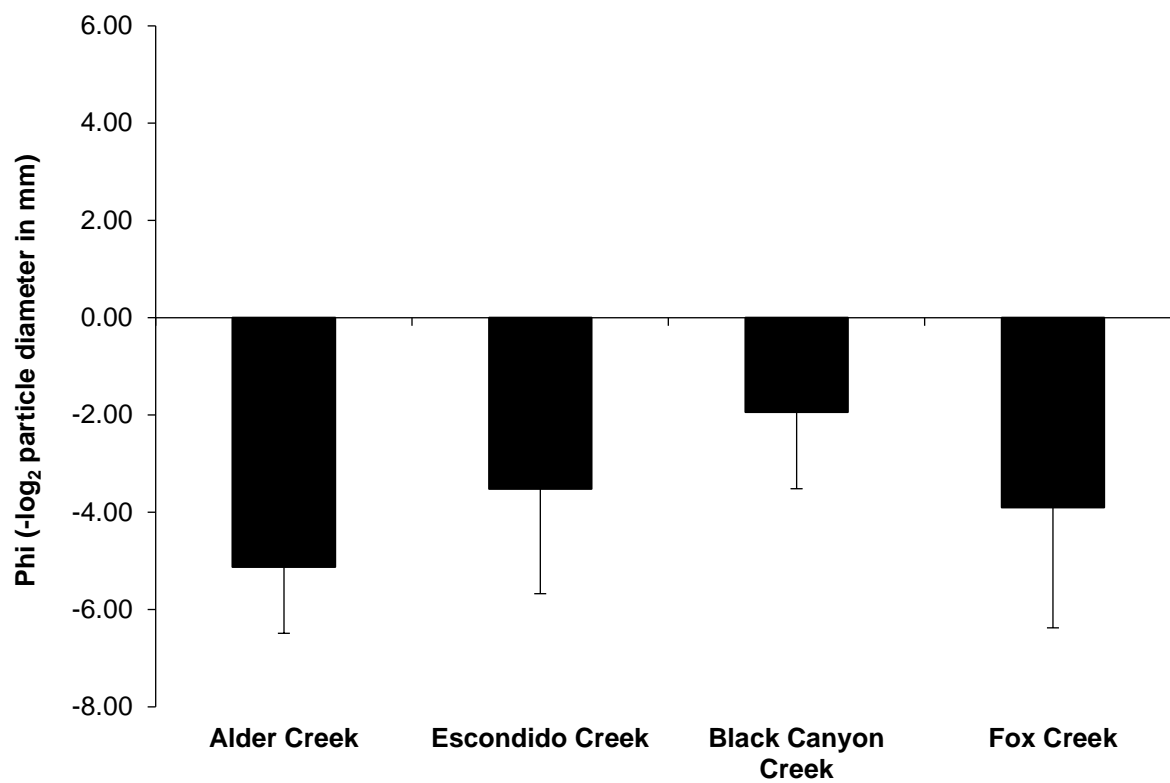
**Figure 3.** Average substrate diameter at sampled streams.

At the onset of our project, we knew that we would encounter a few dry creeks owing the extensive drought affecting the region. As a result, we were only able to sample four of the nine creeks surveyed. Alder Creek, Black Canyon Creek, Fox Creek and Escondido Creek were the only creeks with flowing water (Appendix C). There is a possibility that East and West Fork Santa Cruz creeks had water, but due to remoteness in the LPNF backcountry we were unable to access most of it. The physical and chemical measurements taken at each of the streams suggest that most of the creeks were suitable for fish (Table 1). Ideal habitat requirements for rainbow trout (*O. mykiss*) include clear, cold water, with rocky substrates in riffles and pool-riffle ratios of approximately 1 (Raleigh et al. 1984). Substrate characteristics at each creek indicate that Alder, Fox, Escondido and Black Canyon consist of large pebbles, large gravel, large gravel and medium gravel, respectively (Appendix B).

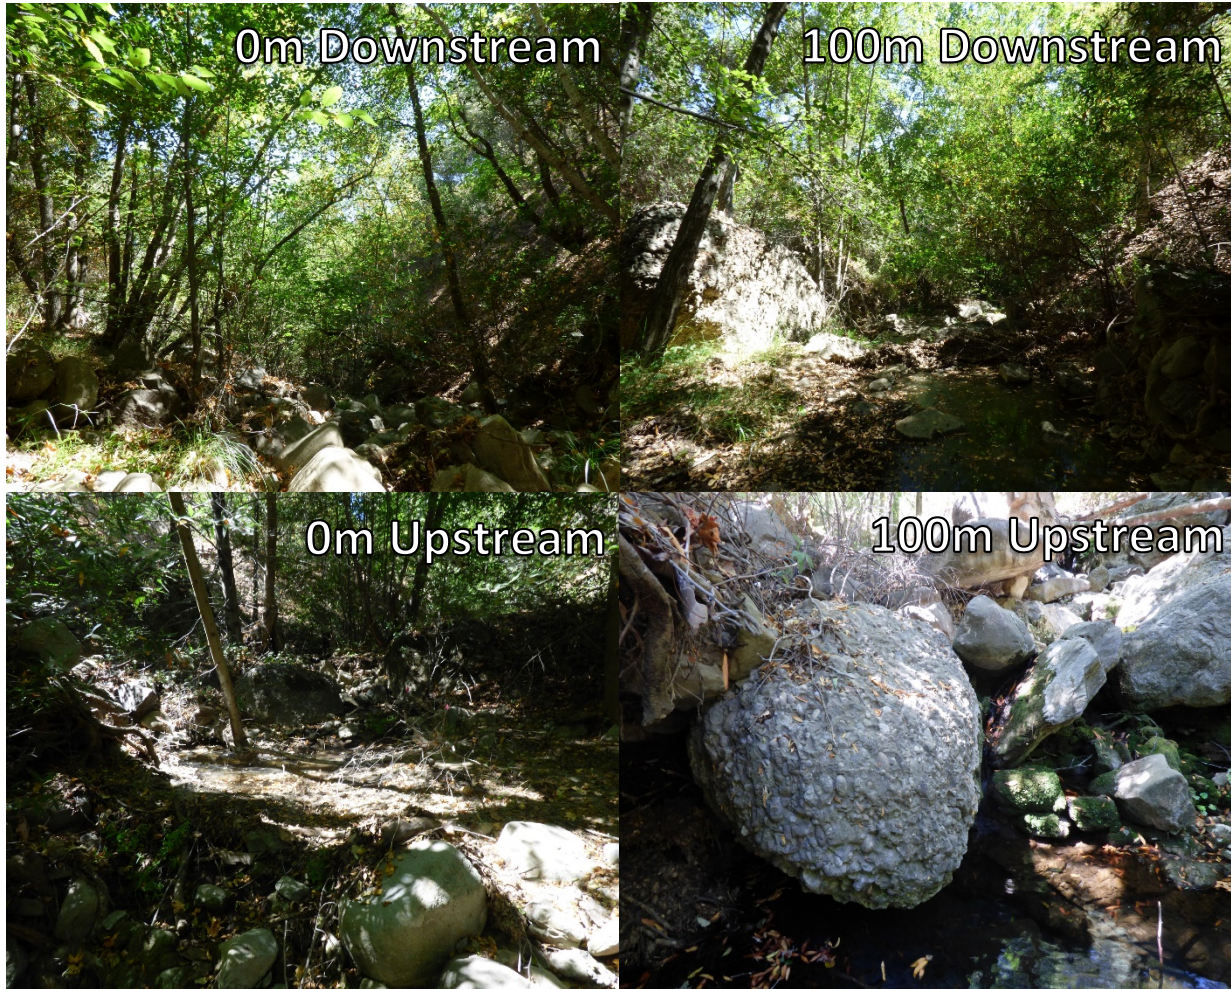
**Figure 5** - Downstream and Upstream View at Black Canyon Creek  
Black Canyon Creek - July 11, 2016  
Santa Barbara County, California  
Coordinates: 34.63214, -119.7657

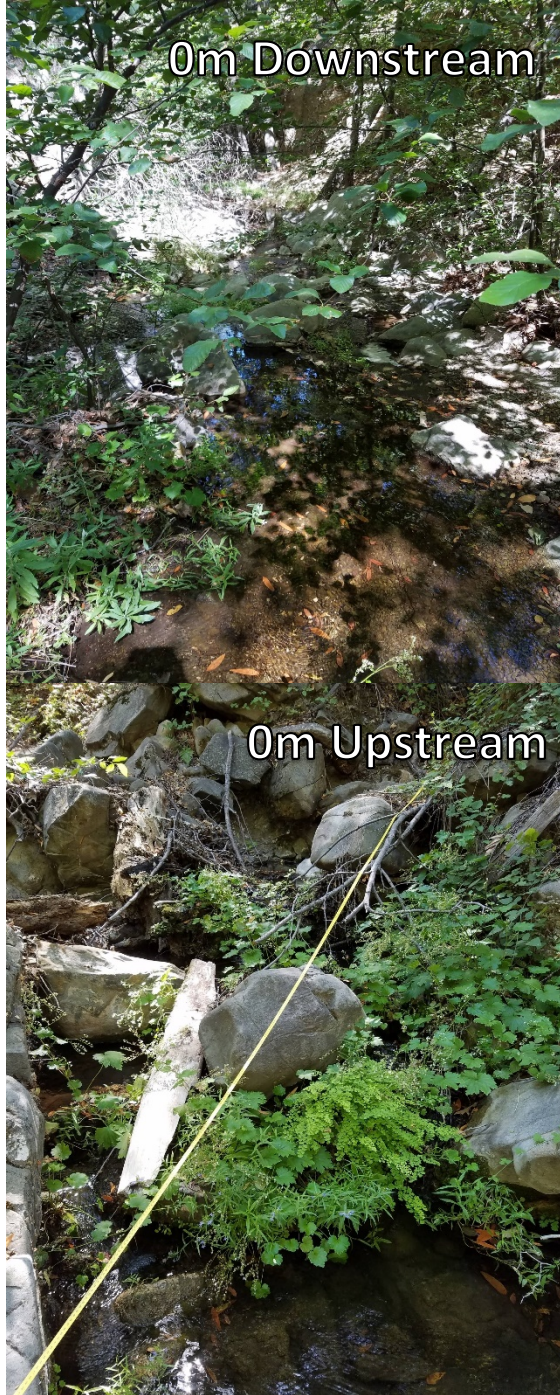
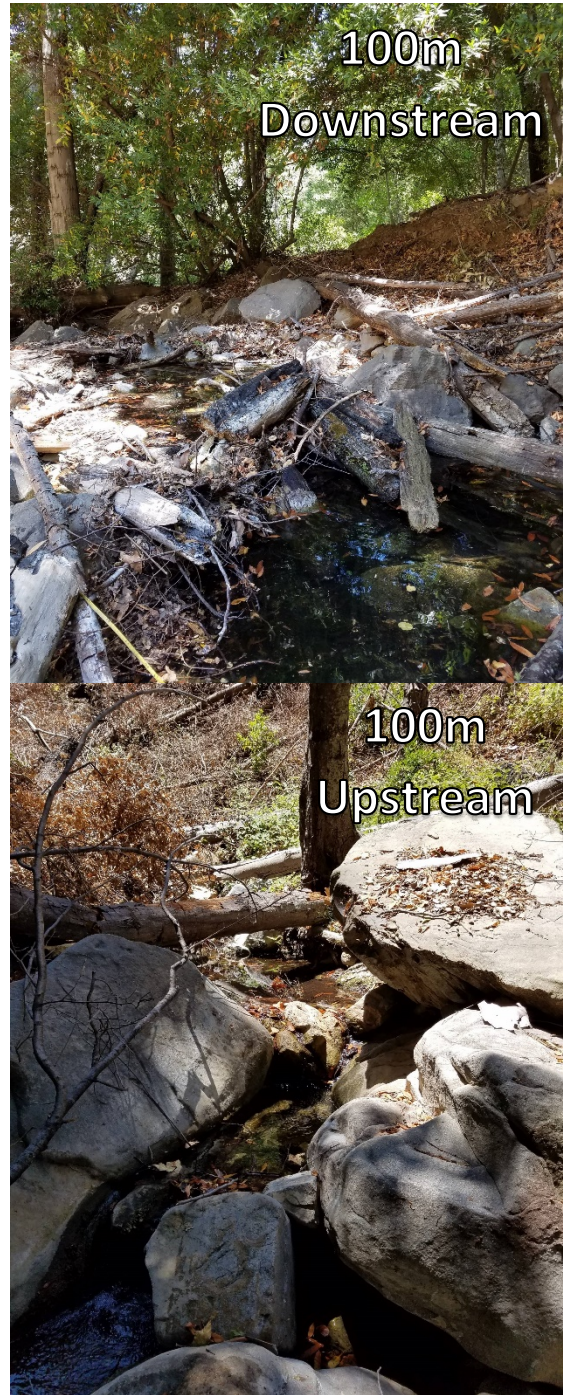
**Figure 6** - Downstream and Upstream View at Alder Creek  
Alder Creek - July 27, 2016  
Santa Barbara County, California  
Coordinates: 34.482978, -119.495123

The only stream containing trout was Alder Creek. The headwaters of Alder Creek serve as a source of water for Jameson Lake, which provides municipal water for the City of Montecito. Alder flows past Jameson Lake into the Santa Ynez River; however, there is a diversion dam that is roughly 12 feet tall that diverts some of that water into Jameson Lake. At the bottom of the debris dam we saw one single adult fish; however, upstream were multiple juvenile fish that appeared to be rainbow trout (*O. mykiss*). This supports Limburg and Waldman (2009) argument that dams have adverse effects on fish communities by disconnecting and isolating them.
